MoorLIFE: Changes to the water table and carbon budget

October 2015

(LIFE08 NAT/UK/00202)

Moors for the Future Partnership

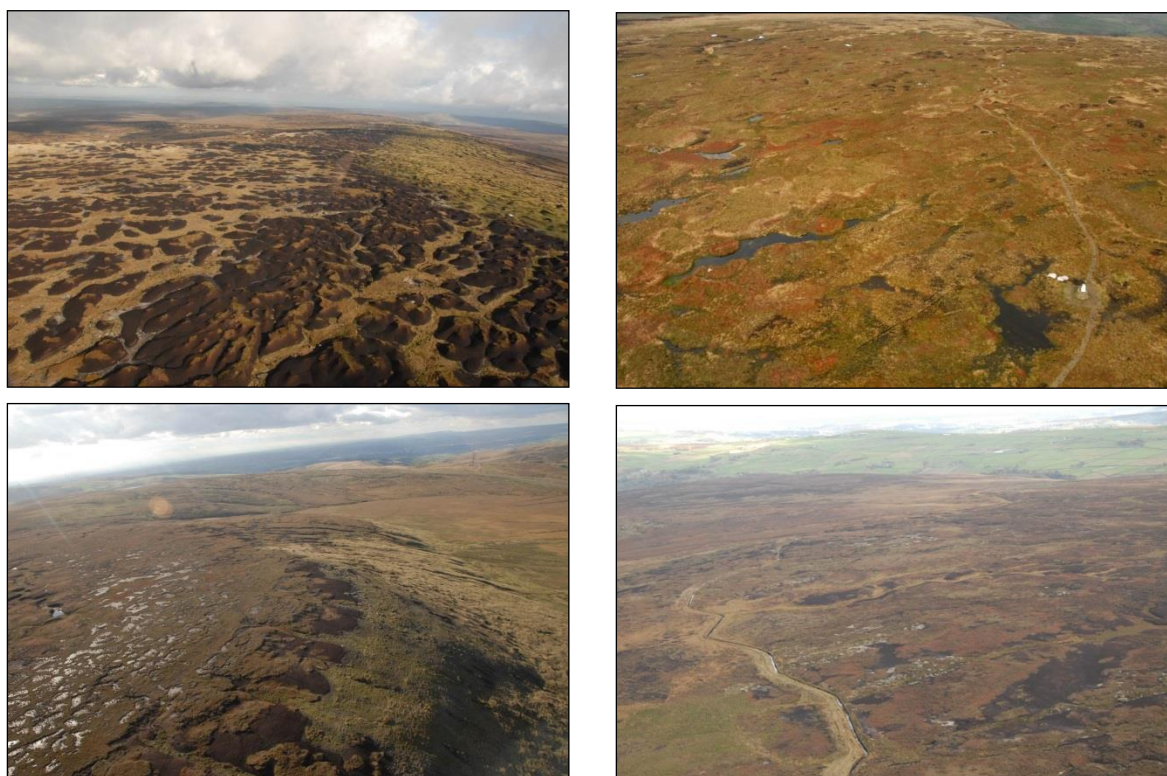
Figure 2 - Aerial views of the four MoorLIFE sites. Clockwise from top left: Bleaklow (Woodhead), Black Hill, Turley Holes and Rishworth Common.

Bleaklow is the second highest hill in the Peak District National Park with a summit of 630m. Extensive areas of bare peat have been successfully revegetated over more than ten years through conservation works (Figure 2). As such some areas of Bleaklow are considered by MFFP as being 'previously' revegetated. Peat stabilisation works (geotextiles, heather brash, lime, seed and fertiliser); diversification (plug planting and *Sphagnum* applications) and gully blocking were undertaken across the plateau by the MoorLIFE project.

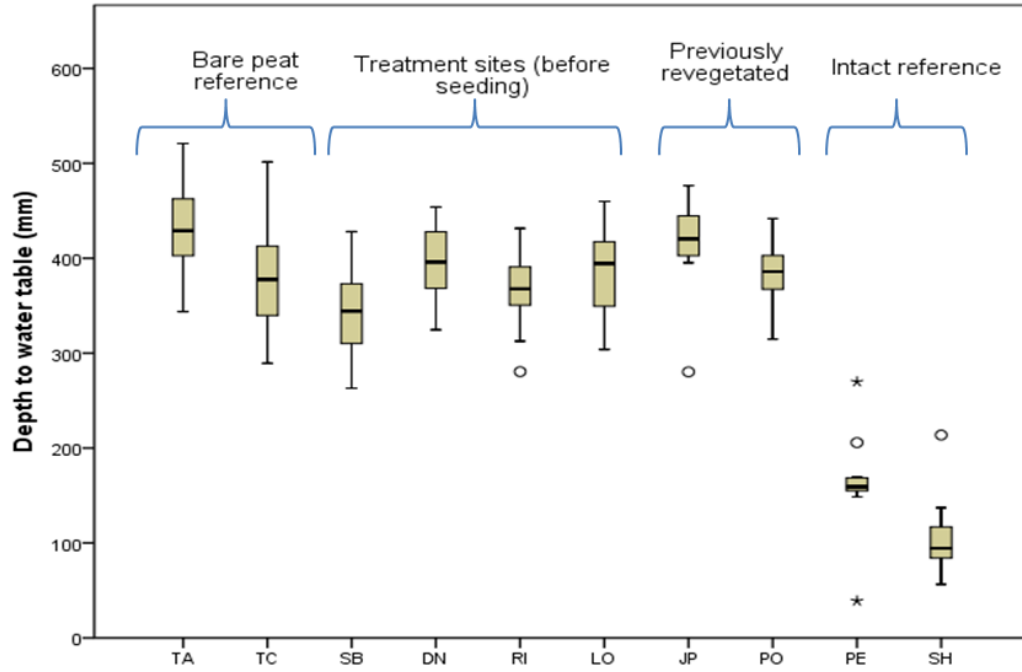
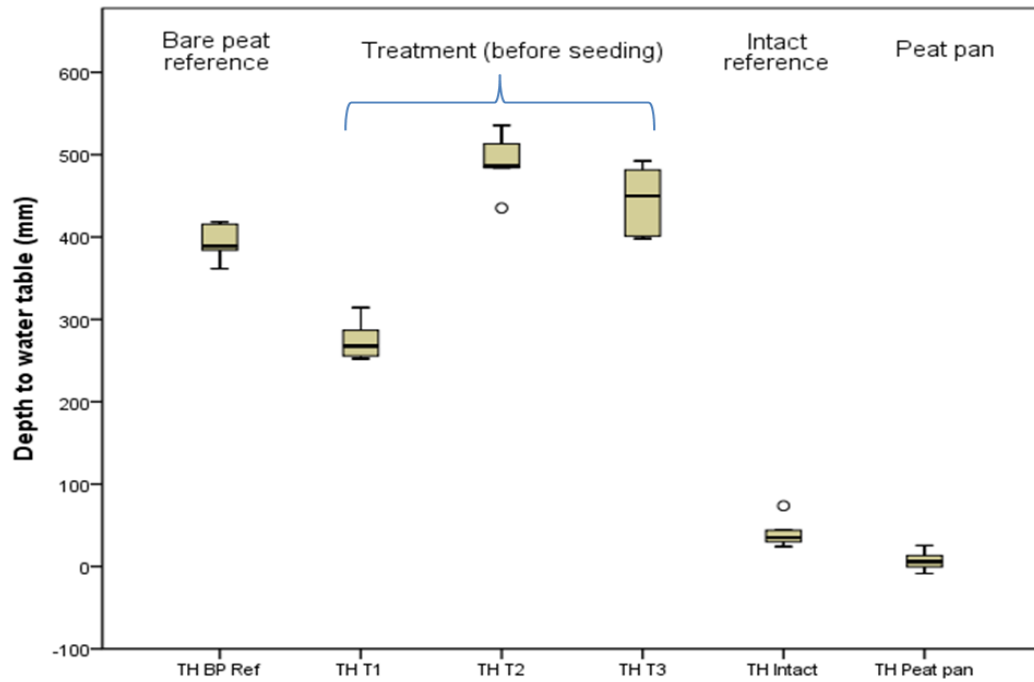
Figure 3 - distribution of water tables at a) Bleaklow and b) Turley Holes in 2011 (before seeding).

Variation in mean water table was also observed between dipwell clusters of the same erosion/treatment state.

Variations between sites of the same erosion/treatment status is likely to be because of several factors, such as topography, hydrological contributing area, slope etc which have an impact on the hydrology of blanket bog. Studying the impacts of these factors on water table depth is beyond the scope of the MoorLIFE project analysis. Therefore, statistical analysis is undertaken on erosion status rather than individual dipwell clusters – the results of which are presented in the following section.

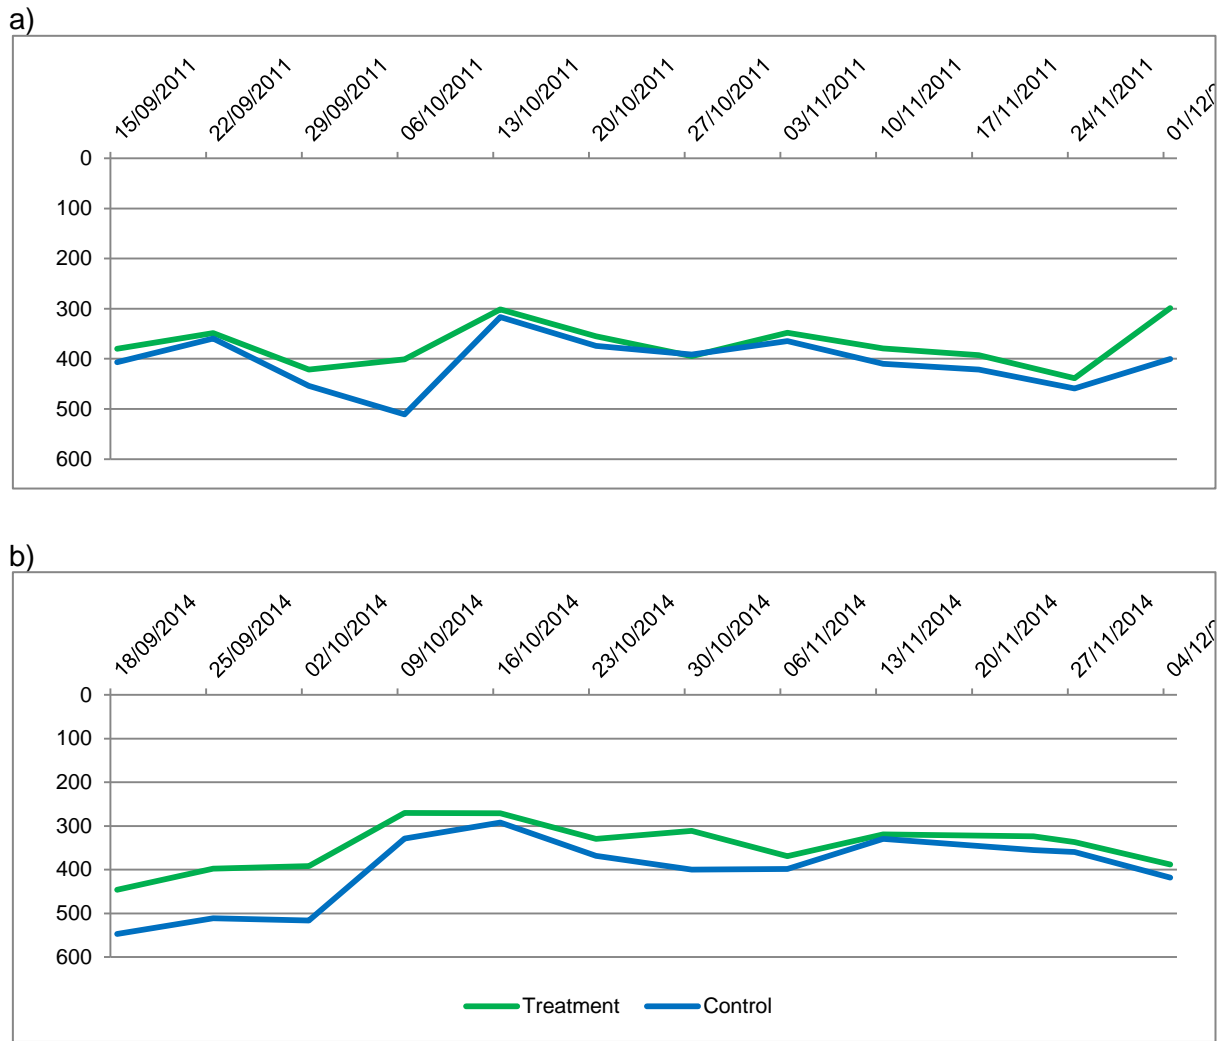
Figure 7 – Treatment and control comparison of depth to water table for Bleaklow study site

Consequently, the differences between water tables at treatment and control sites were calculated and examined before and after re-vegetation. This enabled the relative behaviour of the treated and control sites before and after re-vegetation to be compared.
