The Sustainable Catchment Management Programme (SCaMP) 2005-2010 (-2020)

United Utilities/RSPB

Penny Anderson Associates Ltd

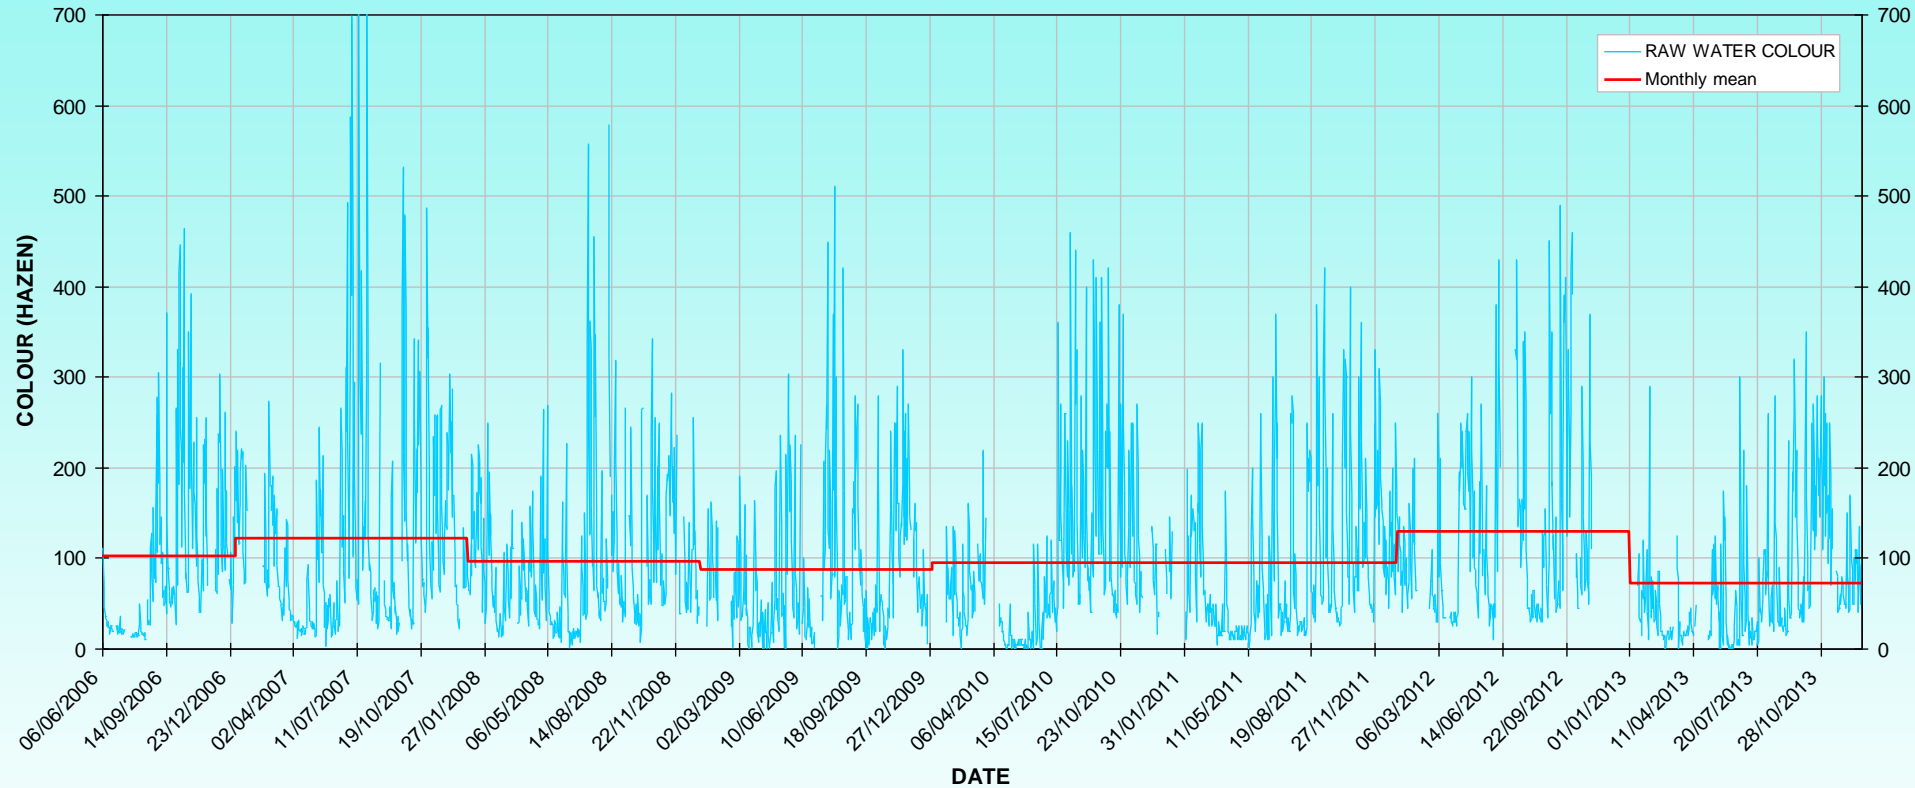
Goyt

Effects of grip blocking on colour

All sites - small, but statistically significant decline in raw water colour after 2 years in Brennand and Goyt, after 5 years in Whitendale

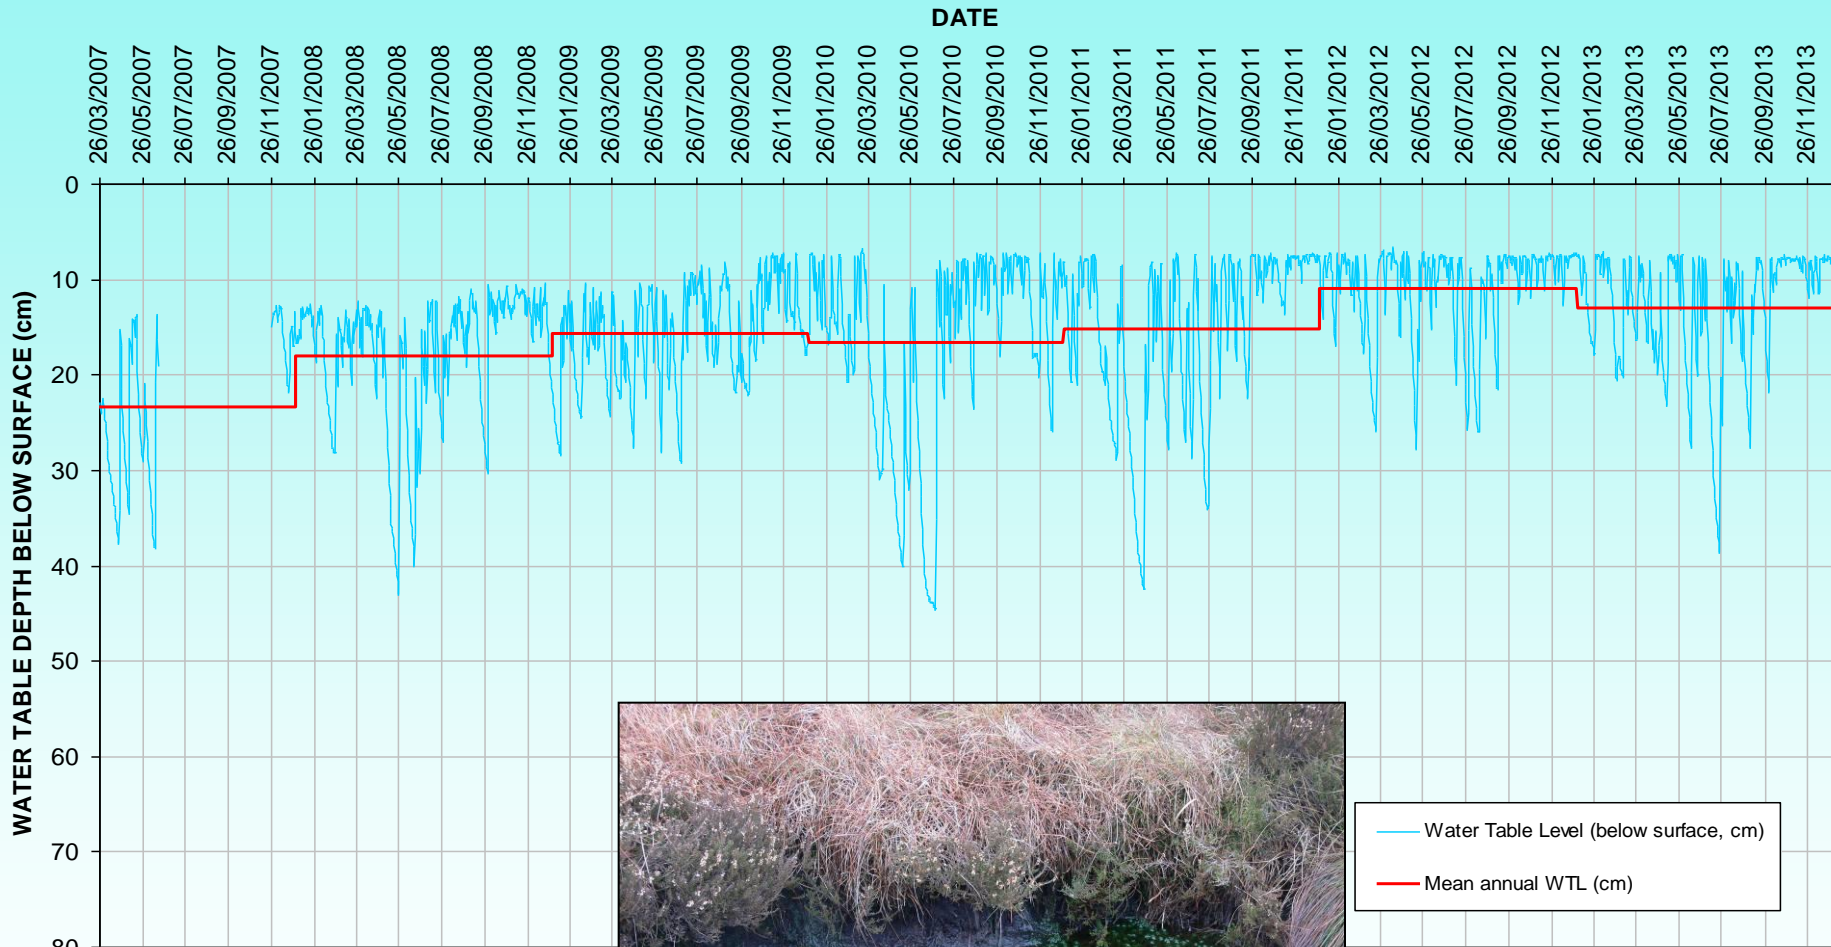
Effects on water table

Statistically higher
water table in Goyt

Lower perturbations

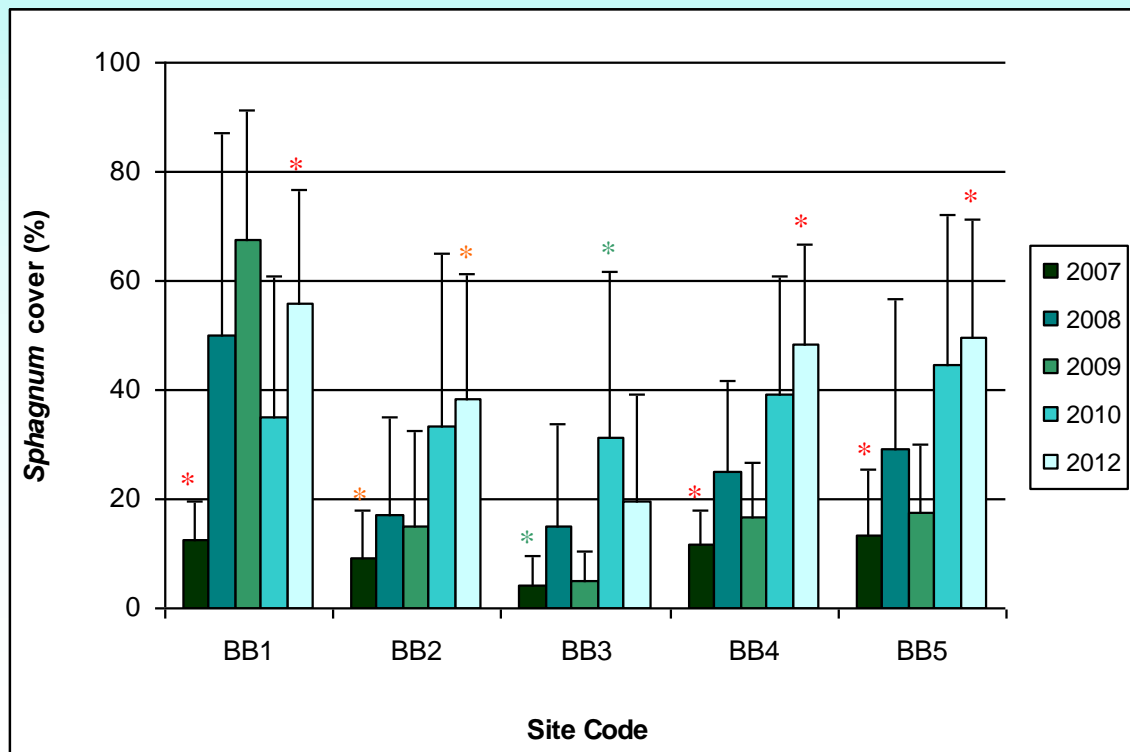
Sphagnum Cover Brennand

before (2007) and after (2009–2012) Restoration Measures
(Mean and Standard Deviation) BB1 – reference site, BB2 and BB3 -
grips blocked eroded catchment, BB4 and BB5 - grips blocked
uneroded catchment

Mostly *Sphagnum fallax*

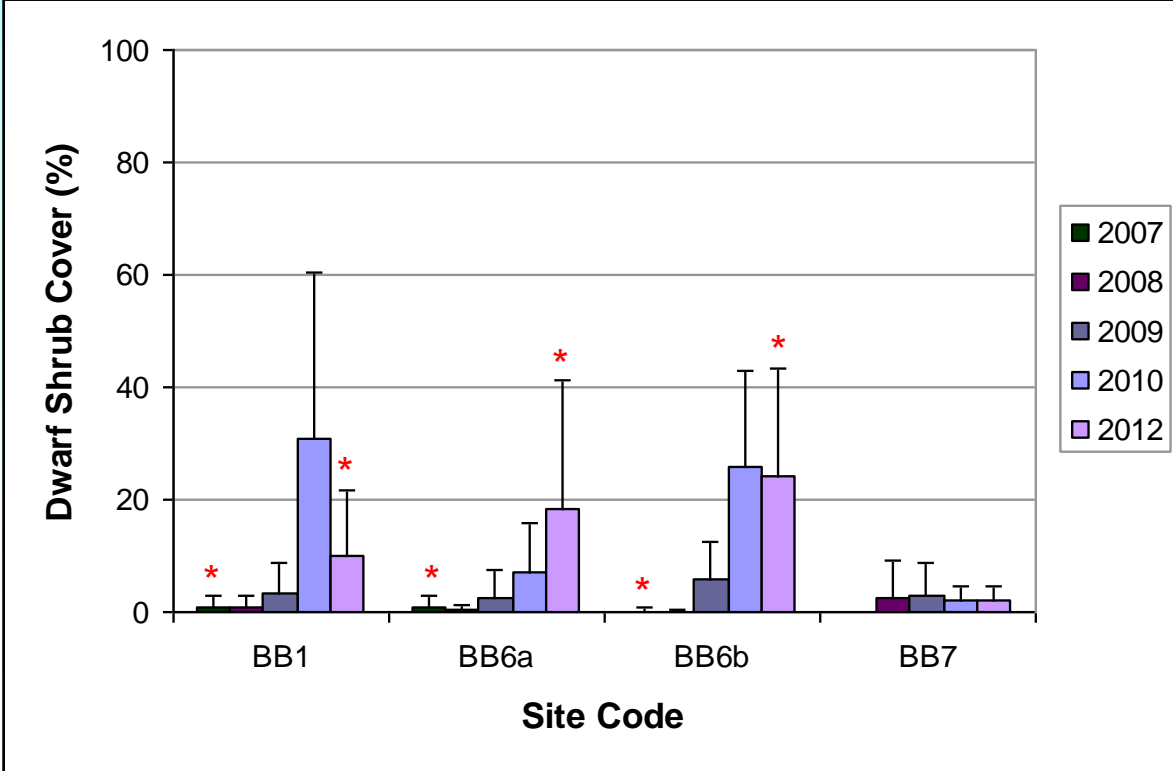
Longdendale – dwarf shrub cover

before (2007) and after restoration

BB1 gently sloping, treated with lime, fertiliser and grass seed

BB6a and BB6b on steeper slopes treated with lime, fertiliser, grass seed and heather brash

BB6b with geojute as well

BB7 reference site untreated

Mostly heather

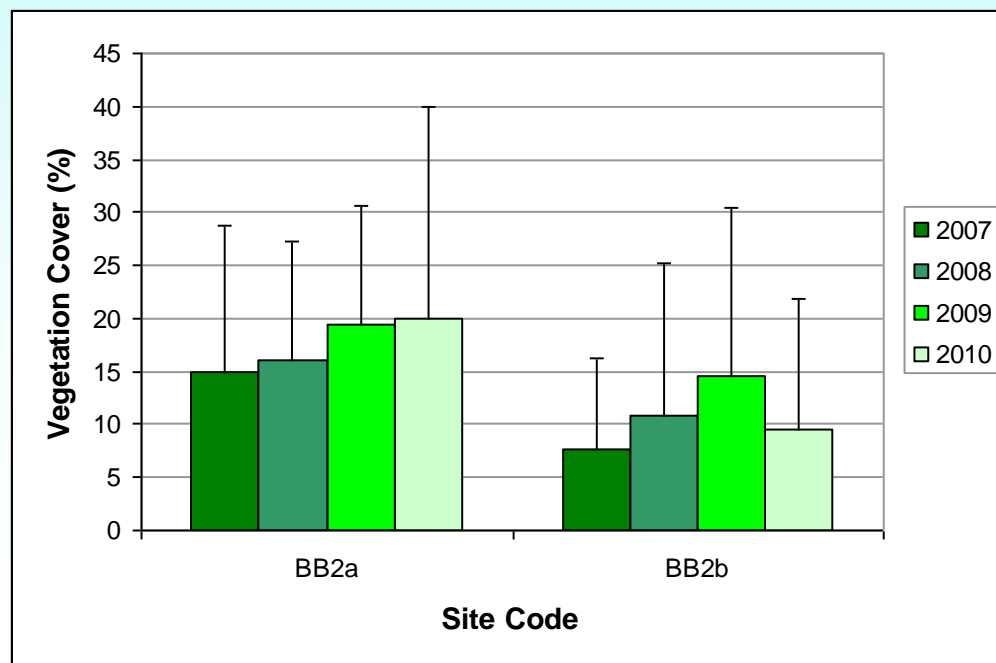
Total Vegetation Cover Baseline Year (2007) and following Restoration Measures (2007 onwards)

Plot BB2a no coir

Plot BB2b coir rolls Installed

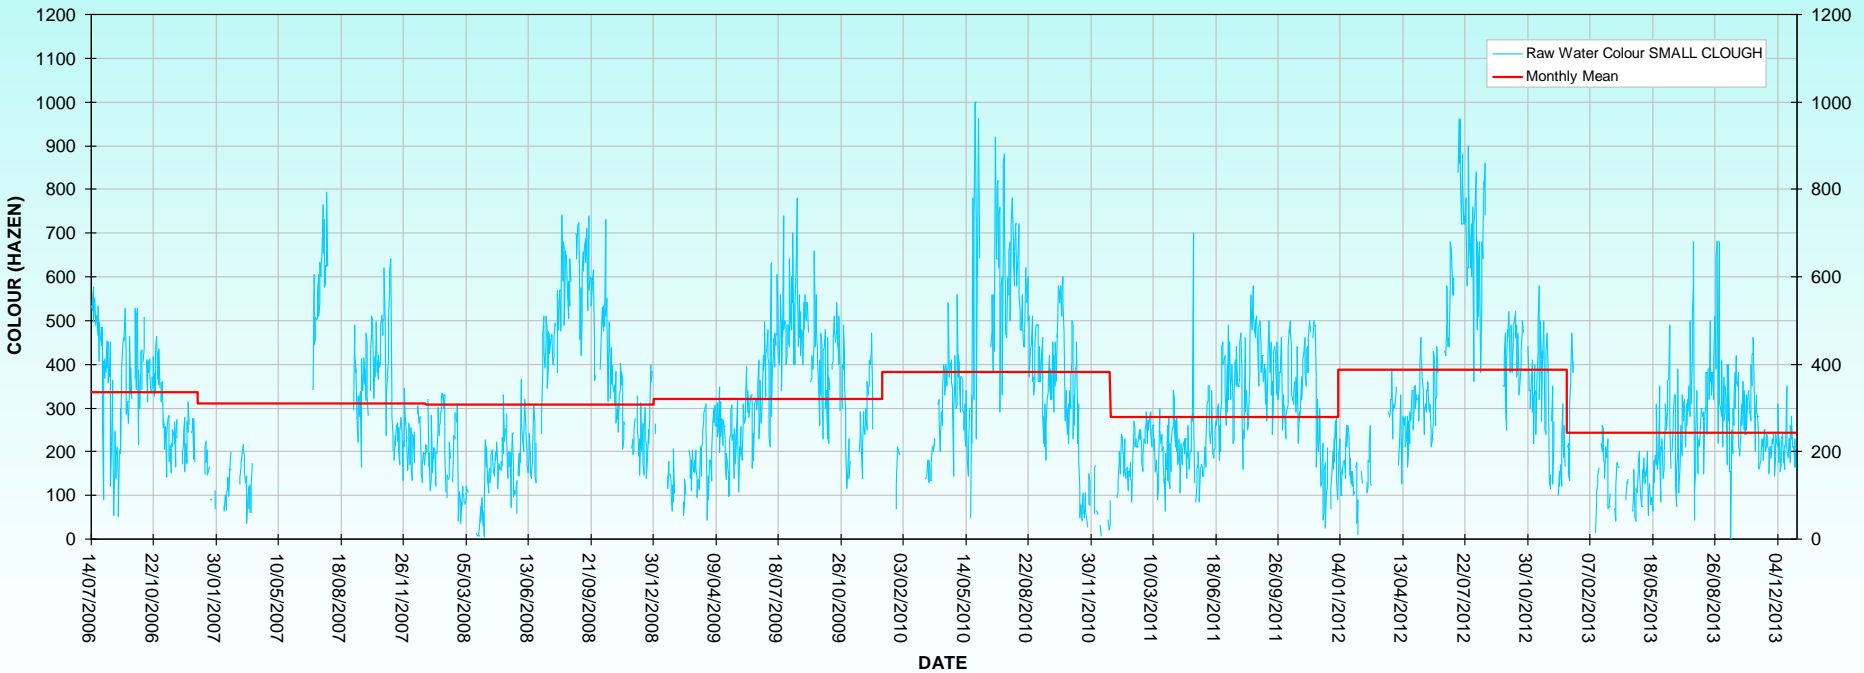
Water quality DOC Small Clough, Ashway Gap

Stable or increasing till 2010, sig. reduction 2010 onwards except 2012 wet summer
